# LANDSLIDE INVESTIGATION THREE FALLS RANCH ALPINE, UTAH

**IGES** Job No. 00608-005

July 20, 2005

Mr. Will Jones Pine Valley Realty

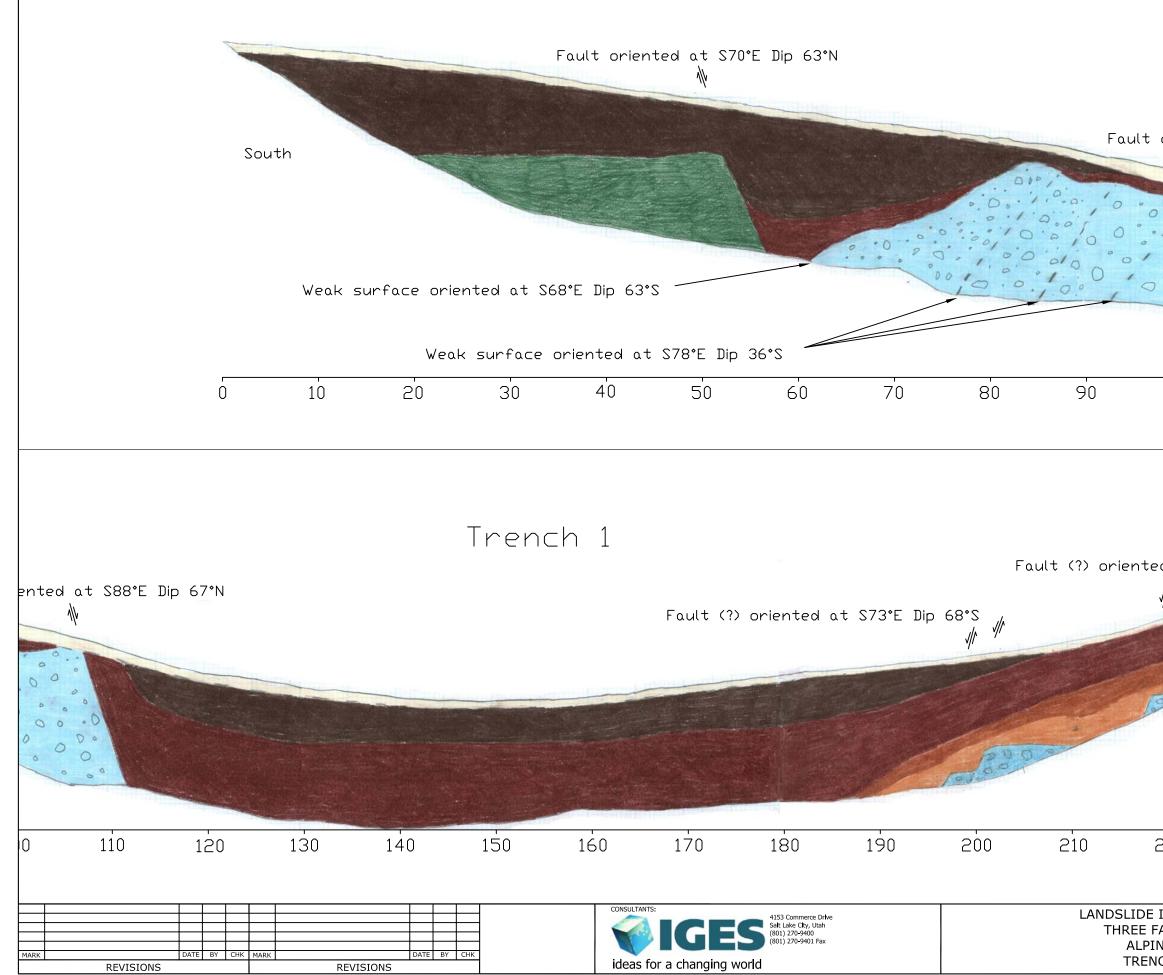
Trench 1 was excavated approximately 247 feet long, and is generally up to approximately 17 vertical feet in depth. The trench is oriented approximately 20 degrees northeasterly with a short northwestward zigzag along the northern end. The trench was excavated through a small gap between two ridges and cut into each ridge. The trench cuts through a mapped scarp feature (Biek, 2005) in the southern end of the trench along the north flank of the southern ridge. The southern ridge, from west to east, trends approximately South 55 degrees East southwest of the trench, and prior to crossing the trench, changes orientation to approximately North 80 degrees East along with the mapped scarp. The northern small ridge is oriented approximately North The soils and structural features exposed in Trench 1 were observed and logged by an engineering geologist. The trench was logged from the south end to the north end.

Two larger faulting features were apparent in the southern potion of Trench 1 coinciding with the mapped landslide scarp feature. The faults were oriented at approximately South 70 and 88 degrees East, and dipped towards the North at 63 and 67 degrees respectively. The apparent offset of the faults appeared to be greater than 8 and 14 feet respectively measured vertically.

Soils exposed in the fault blocks in the southern end of Trench 1 consisted of a pebbly, grusified appearing Silty Sand soil with fine and medium gravels of granitic rock fragments and trace amounts of limestone and quartzite, with a decomposing granite cobble, overlain by a Silty Clay/Clayey Silt soil with increasing clayey content towards the surface, with decreasing gravel content downslope. The Silty Sand soil resembles mapped (Biek, 2005) finer grained portions of glacial outwash or till deposits of the Dry Creek glacial advance (Qgod and Qgtd). The other soil exposed in the lower fault block in the southern end of the trench consisted of a jumbled mix of poorly sorted Silty and Clayey Gravels with cobbles and small boulders consisting of sub-angular and some subrounded clasts of carbonate coated limestones and some quartzite/sandstones, and a small block (small boulder) of pulverized decomposing marbleized limestone. The clasts were generally fractured and disintegrating. Soils exposed in the south side of the block

(opposite the lower southern fault trace) dip southward towards the upper south side fault, with apparent parallel stratifications features throughout the block oriented approximately North 78 degrees East dipping southward approximately 36 degrees. Soils above the gravel soils of the lower exposed fault block and fill in between the lower block and blocks consists of brown highly plastic Clay with some subangular gravel sized clasts of orthoquartzite with lesser amounts of limestone. The silt and sand content in the clay increases and then decreases to various degrees up to the ground surface above the lower block. Some of the soils constituents of the upper block have been incorporated into the clay and silty clay along the upper south fault contact. The granular soil surface and the lower south fault of the lower southern block forms a small horst feature.

Less apparent were faults in the northern end of Trench 1. Soil materials exposed in the lower portion of the trench side wall resembling fault structures were comprised of angular to subangular carbonate coated gravel, cobble and small boulder sized clasts of limestone (marbleized limestone). The apparent upper and lower faults have orientations of South 80 and 73 degrees, dipping south 66 to 68 degrees respectively, and form a graben feature between the two small ridges. Overlying the coated limestone clasts was angular clasts of brecciated orthoquartzite, which grade upward into a Clayey Gravel consisting of redbrown highly plastic clay containing clasts of the quartzite. The clay content appeared to increase upward towards the surface. The highly plastic clayey gravel soil appeared to grade subtlety to brown Clay with gravel, with lesser and lesser amounts of gravel grading down slope to Silty Clay into the small basin. The clay soils appear to consist of fluidized flow landslides. The overlying fine grained soils, in our opinion do not exhibit landslide features, but appear to have been deposited into the graben depression formed through valley fill processes, slope creep, and possible weathering of fault scarp surface ruptures. No apparent discreet contact or slide plane was observed between the fine grained soils exposed in the trench. Faulting appeared to offset the older units consisting of the marbleized limestone, brecciated orthoquartzite and overlying red-brown and brown fat Clay, and was overlain by weathering products of the clay consisting of less plastic brown clayey and silty clay, and clayey and sandy silt.

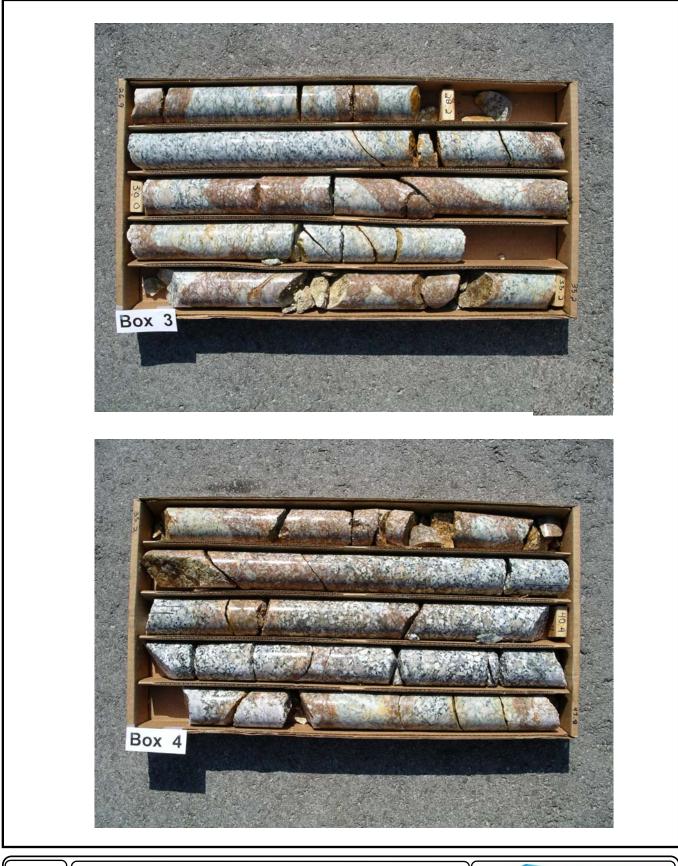
B-1b
 Landslide Investigation

B-1 Core Photo Log 26.9 to 43.8 Feet

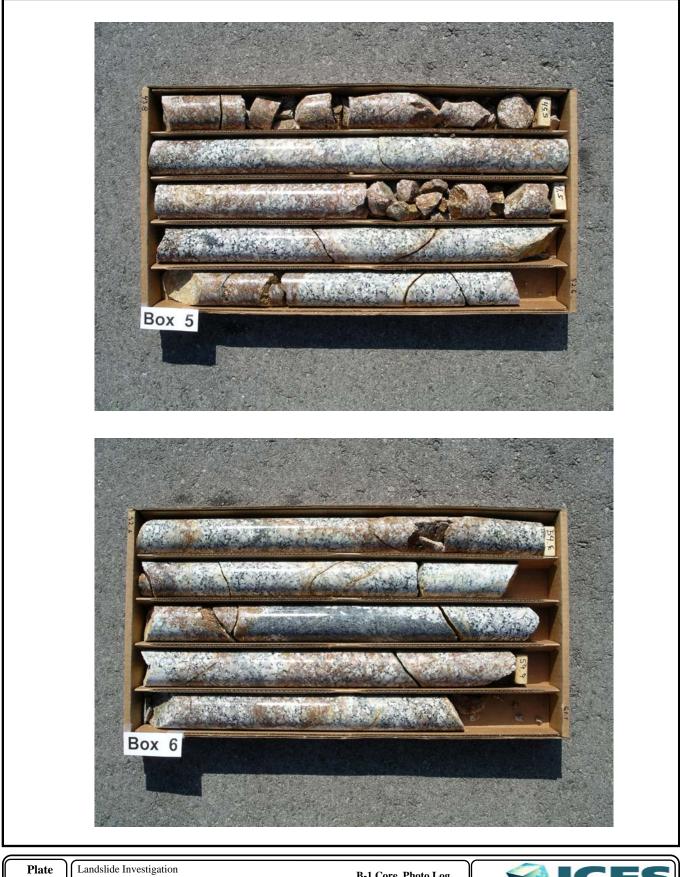
B-1c
 Landslide Investigation

B-1 Core Photo Log 43.8 to 61.1 Feet

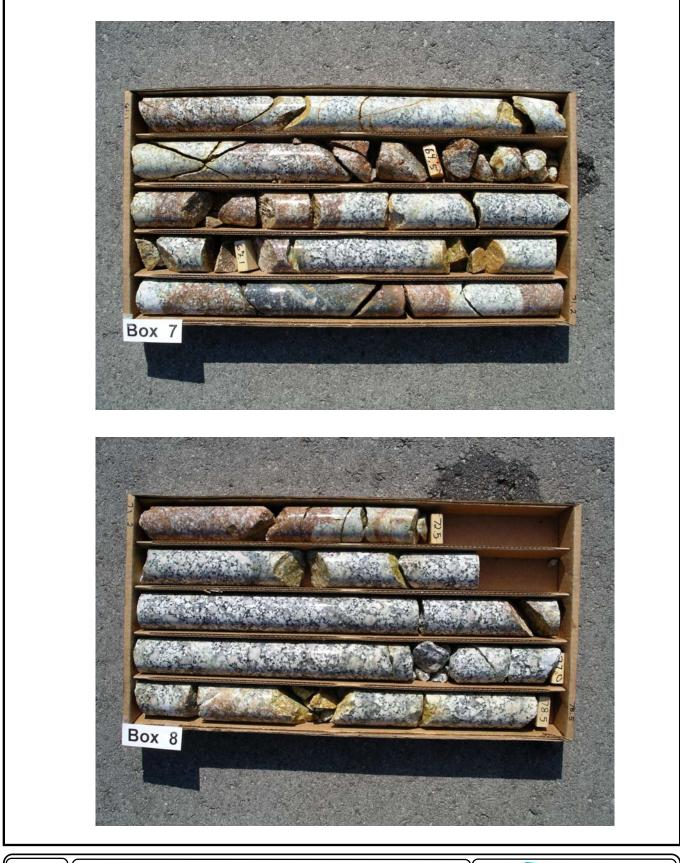
Plate B-1d Landslide Investigation Three Falls Ranch Alpine, Utah

B-1 Core Photo Log 61.1 to 78.5 Feet

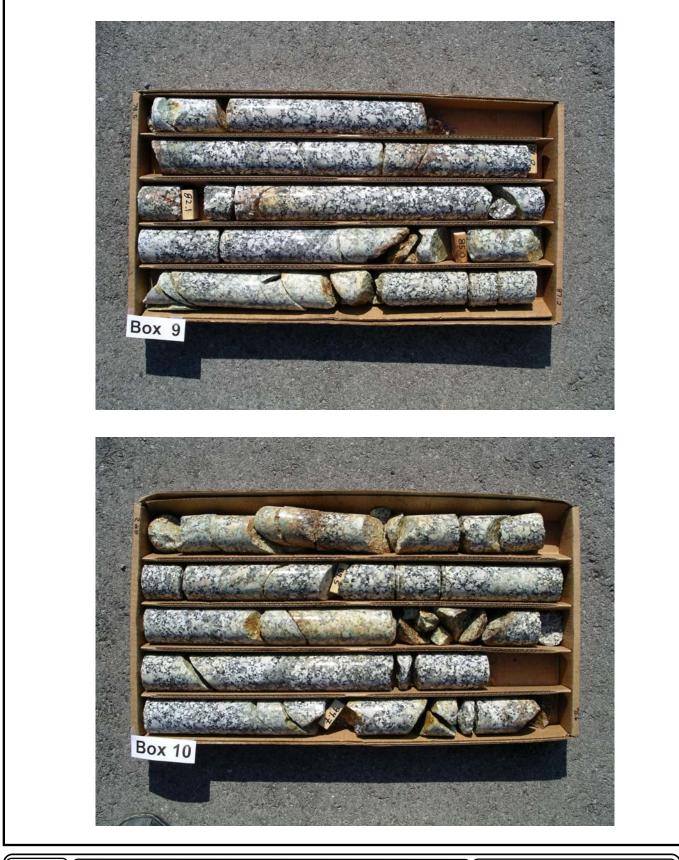
Plate B-1e Landslide Investigation Three Falls Ranch Alpine, Utah

B-1 Core Photo Log 78.5 to 95.6 Feet
